What we learned:

Building performance study of the WTC collapse

By **W. Gene Corley Ph.D., S.E., P.E.**

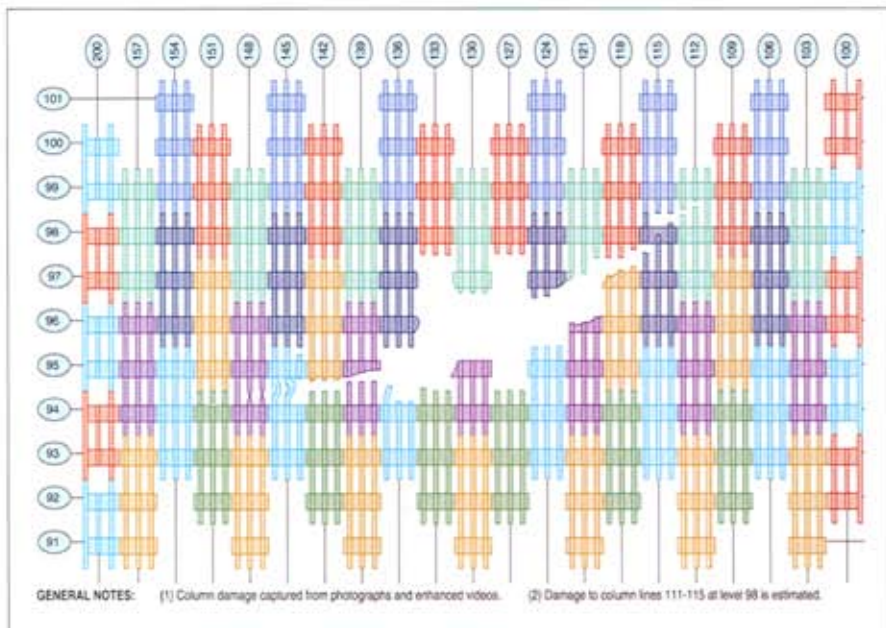
Additional damage occurred where the jet's wings hit the wall, with 31 to 36 columns destroyed over a four-story range (see Figure 1). This damage led to partial floor collapse over a horizontal length of about 65 feet. Some damage to steel framing at the center core also was apparent. Eyewitnesses described evidence of partial floor collapse inside the building, including areas on the 91st floor that were blocked by debris from higher floors (see Figure 2).

Figure 1: Impact damage to exterior columns on the north face of WTC 1.

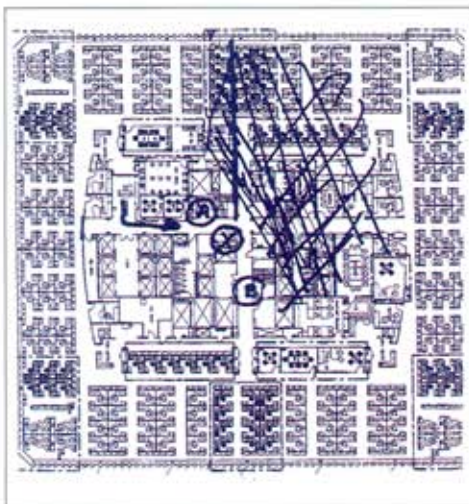
Figure 2: (Right) This sketch, made during survivor interviews, shows approximate debris location on the 91st floor of WTC 1.

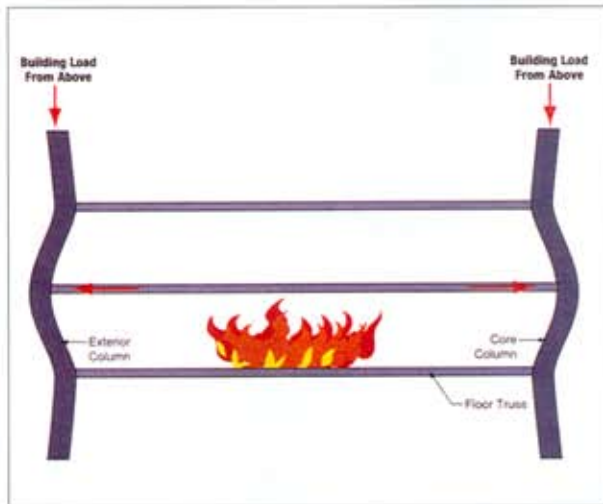
Figure 3: (Far right) Expansion of floor slabs and framing results in outward deflection of columns and potential overload.

potentially developed major additional stresses in some elements. If the resulting stress state exceeded the capacity of some members or their connections, it could have initiated a series of failures (see Figure 3).

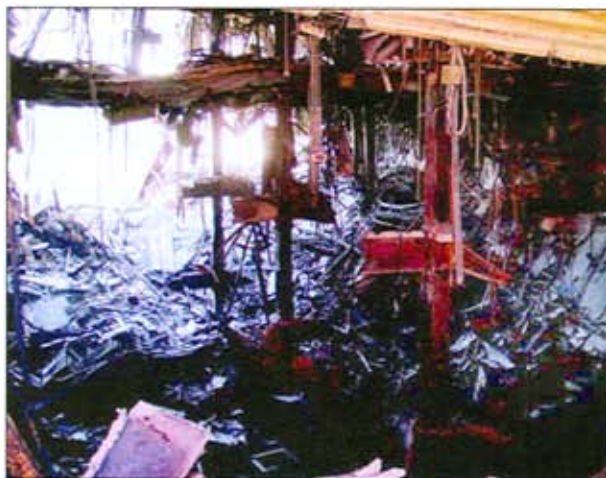
Local collapse mechanisms — Two areas in WTC 5 experienced local collapse under an intact portion of the roof. Although there was debris impact near this area, the symmetry of the collapse suggests that uncontrolled fires caused these failures. Columns in this area remained straight and freestanding — an observation that lends support to this theory (see Figure 5). Local collapse appears to have

begun at the field connection where beams were connected to shop-fabricated beam stubs and column assemblies.

It seems that the structural collapse resulted from excessive shear loads on bolted connections and unanticipated tensile forces resulting from the beams' catenary sagging. High shear loads, probably attributable to collapsing floor loads above, were evident in many of the column-tree beam stub cantilevers.

Figure 5: Internal collapsed areas in WTC 5.
