# Condominium Railing + Balcony Materials Failure Investigation

MIAMI, FLORIDA

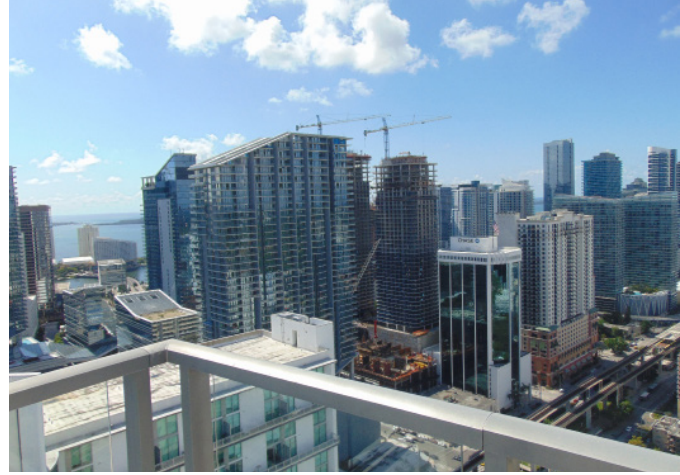
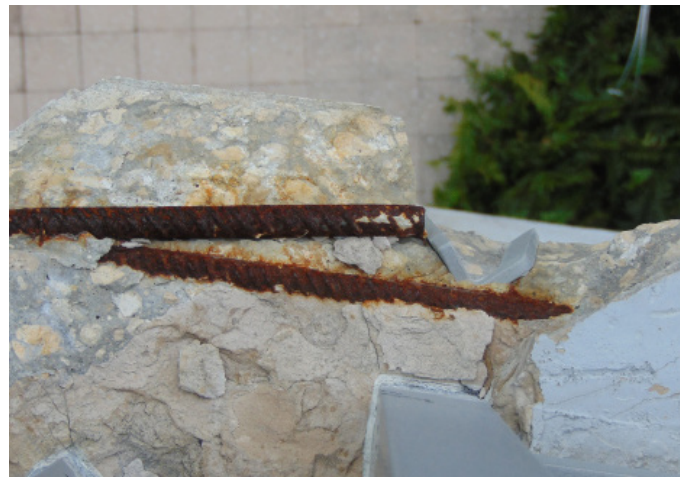
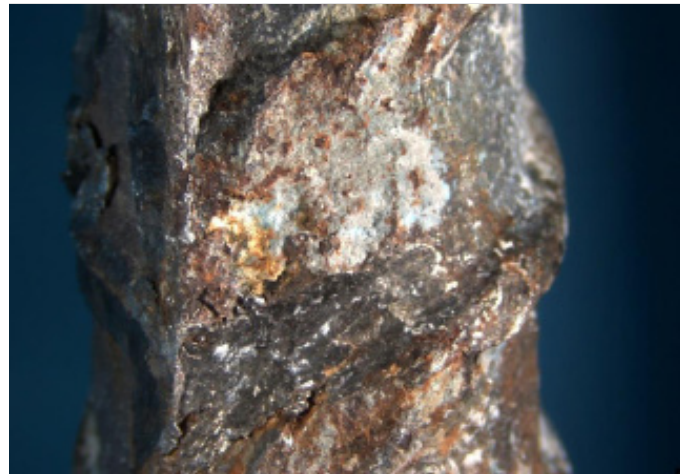
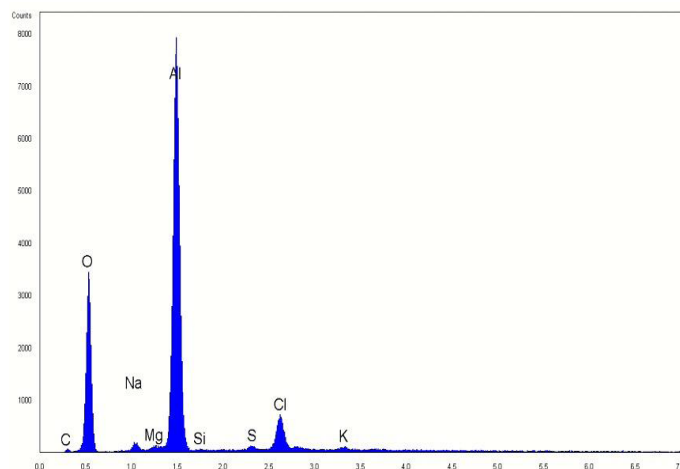
Observed corrosion of reinforcing bars (rebar situated within the balcony concrete), the delamination, spalling and cracking of post pocket grout and balcony concrete surrounding the aluminum railing columns (posts), as well as aluminum balcony railing coating failures and railing corrosion were material defects investigated.

The laboratory investigation confirmed the presence of corrosion products on aluminum railings and exposed rebar and revealed that an alkali resistant coating was not applied to the aluminum railing embedded in the post pocket grouts. Further, the railing coating was identified as a polyester powder type and not a more durable PVDF coating.
