# Condominium Railing + Balcony Materials Failure Investigation

*Miami, FL*

CTLGroup personnel were retained as experts to investigate failure mechanisms of balconies on a highrise condominium in downtown Miami, Florida.

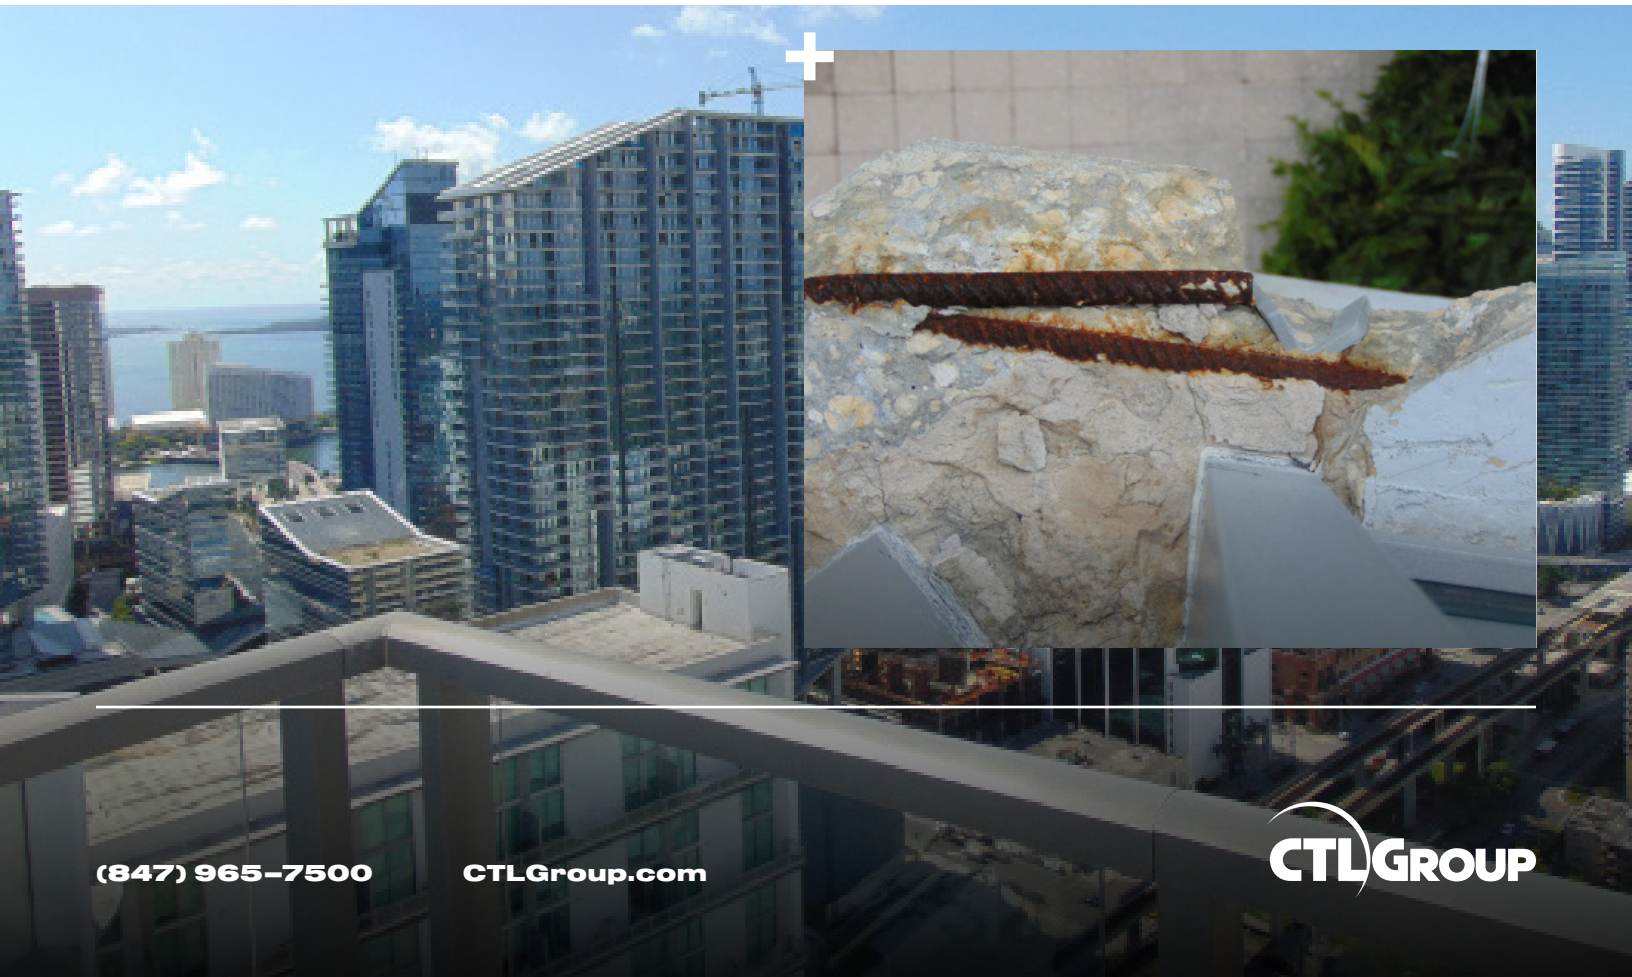
Observed corrosion of reinforcing bars (rebar situated within the balcony concrete), the delamination, spalling and cracking of post pocket grout and balcony concrete surrounding the aluminum railing columns (posts), as well as aluminum balcony railing coating failures and railing corrosion were material defects investigated.

The field evaluation determined that the defects observed on the railings included paint delamination and blistering along with visual evidence of aluminum corrosion beneath the coating in delaminated areas. The exposed rebar was found to be positioned in close proximity of the aluminum railings; at odds with Florida building codes.

The laboratory investigation confirmed the presence of corrosion products on aluminum railings and exposed rebar and revealed that an alkali resistant coating was not applied to the aluminum railing embedded in the post pocket grouts. Further, the railing coating was identified as a polyester powder type and not a more durable PVDF coating.
