# Metallurgical Evaluation of Cracked In-Service Heavy Duty Pile Bonnets

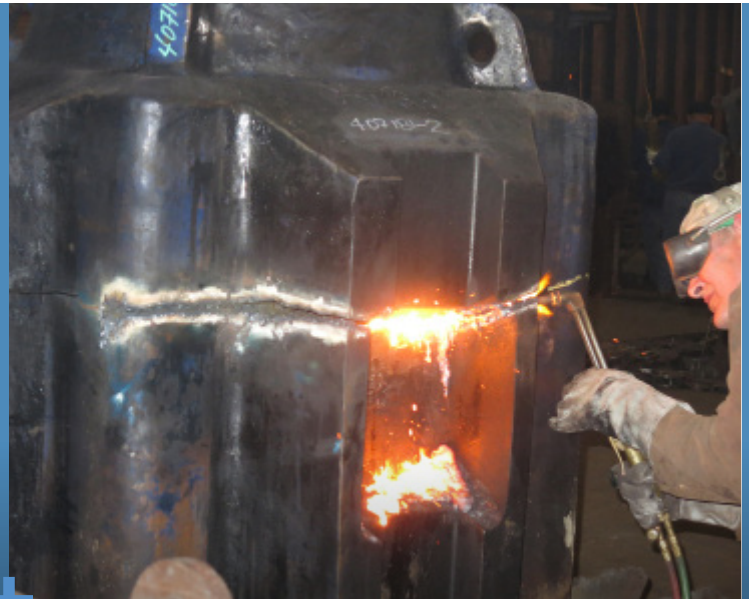
Fractures appeared to progress along significant portions of the pile bonnet perimeter, and penetrated full cross-sectional thickness for a significant portion of the crack propagation path. Examination of the fracture within the pile insert receptacle cavity revealed that the fracture path propagated through the toe of the casting radius formed at the cushion receptacle, adjacent to the pile insert receptacle cavity wall.

DPA revealed that the cracking resulted from multiple origin fatigue fractures, which initiated around the entire circumference of the cast surface of the pile internal insert cavity wall. At some point during the pile bonnet operational lifetime, primary fatigue cracking was arrested, and secondary fatigue was re-initiated at the arrest locations of the primary fatigue propagation.

Metallographic specimens revealed the presence of a significant layer of oversized MnS and SiO<sub>2</sub> inclusions at the primary fatigue origins. CTLGroup determined that the observed microstructural anomalies, which are indicative of poorly controlled foundry practices, compromised the functional integrity of the pile bonnets and resulted in premature failure of the units.
