The World Trade Center collapse and its implications for International Standards

By Dr. W. Gene Corley, Senior Vice President of Construction Technology Laboratories, Inc., Skokie, Ill. (USA), and leader of the FEMA and SEI/ASCE Building Performance Study Team for the World Trade Center, Chair of ISO/TC 71, Concrete.

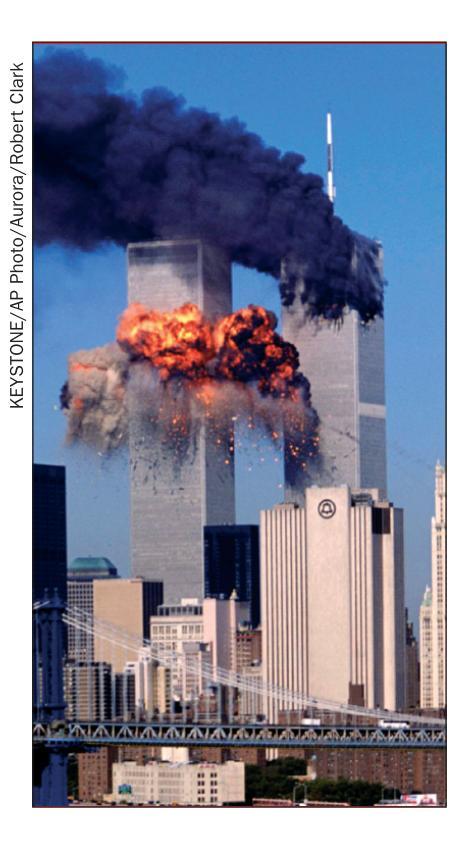
The aircraft that struck the twin towers each carried about 37850 liters of fuel at the time of impact. As no flame was evident immediately upon impact, the fuel likely was distributed in a flammable cloud throughout the impact area. Its ignition caused a rapid rise in pressure, then the expulsion of fireballs into shafts and through openings.

These fireballs did not explode or generate a shock wave, and thus did not in themselves cause structural damage. Calculations show they did, however, burn 3785 to 11360 liters of jet fuel quickly. The remaining fuel appears to have burned off within minutes, generating enough heat to ignite virtually all the combustible materials on the impacted floors and within the planes.

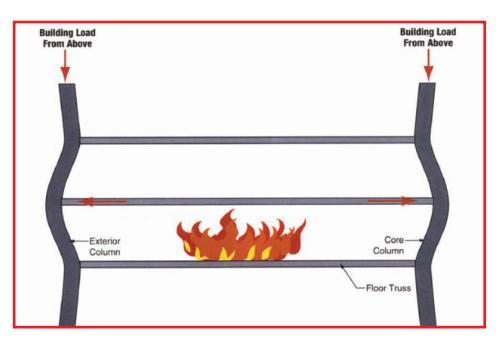
Expansion of floor slabs and framing results in outward deflection of columns and potential overload.
