What we learned:

Building performance study of the WTC collapse

By **W. Gene Corley Ph.D., S.E., P.E.**

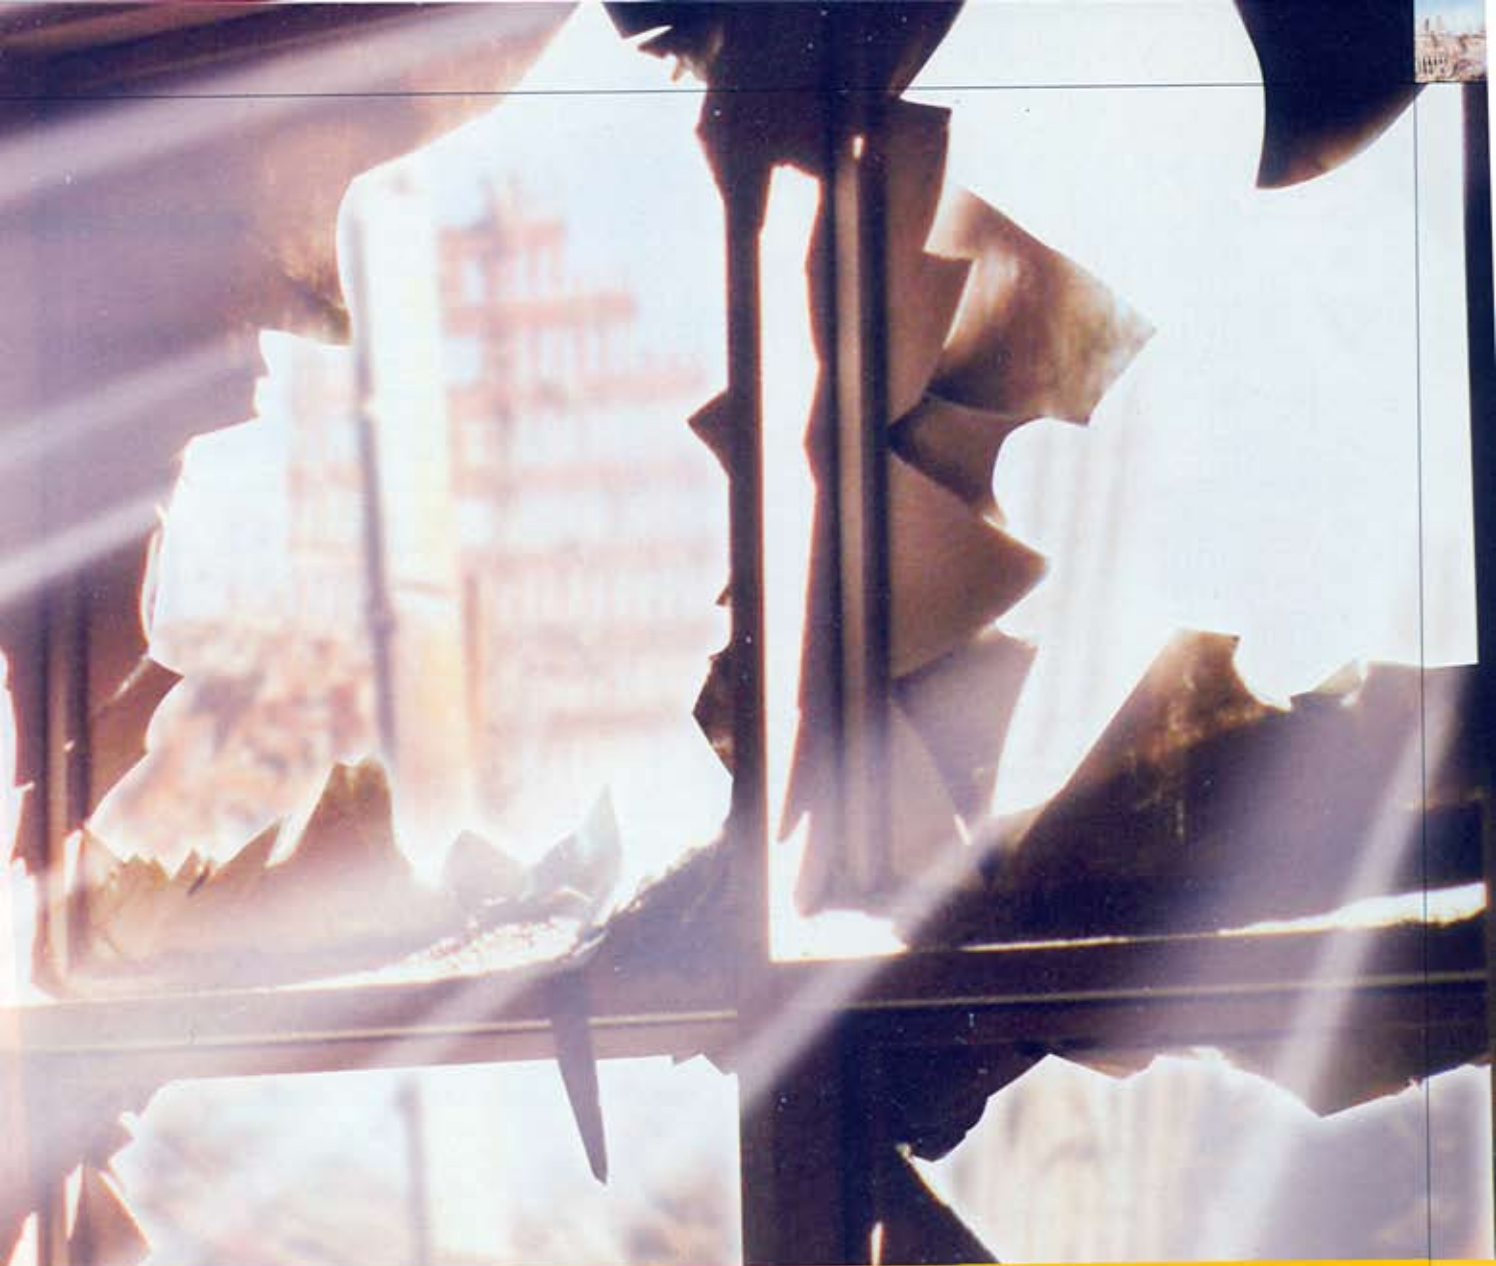
Additional damage occurred where the jet's wings hit the wall, with 31 to 36 columns destroyed over a four-story range (see Figure 1). This damage led to partial floor collapse over a horizontal length of about 65 feet. Some damage to steel framing at the center core also was apparent. Eyewitnesses described evidence of partial floor collapse inside the building, including areas on the 91st floor that were blocked by debris from higher floors (see Figure 2).

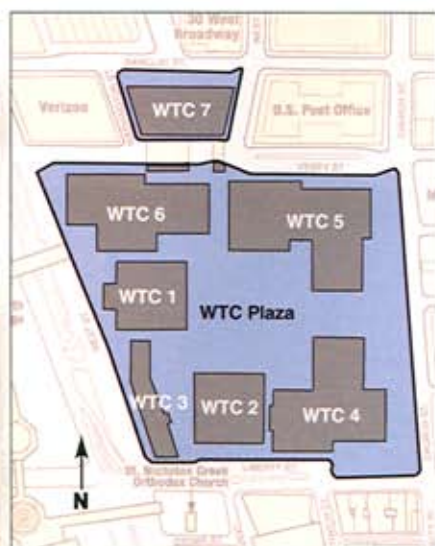
Two nine-story and one eight-story steel-framed office buildings (WTC 4, WTC 5, and WTC 6) were located on the north and east sides of the WTC Plaza (see Figure 4). When the first two towers collapsed, all three were subjected to severe impact damage as well as fires that developed from the flaming debris. Most of WTC 4 collapsed when the exterior column debris from WTC 2 hit it; the remaining section had a complete burnout. Debris from WTC 1 impacted both WTC 5 and WTC 6, causing large sections of localized collapse and subsequent fires. All three buildings resisted

Figure 4: Site plan of the WTC complex.
