# Coal-Fired Electric Plant Coal Bunker Fire

CTLGroup was retained by a power utility company to perform an emergency assessment at its coal-fired electrical power generation plant, due to an equipment fire.

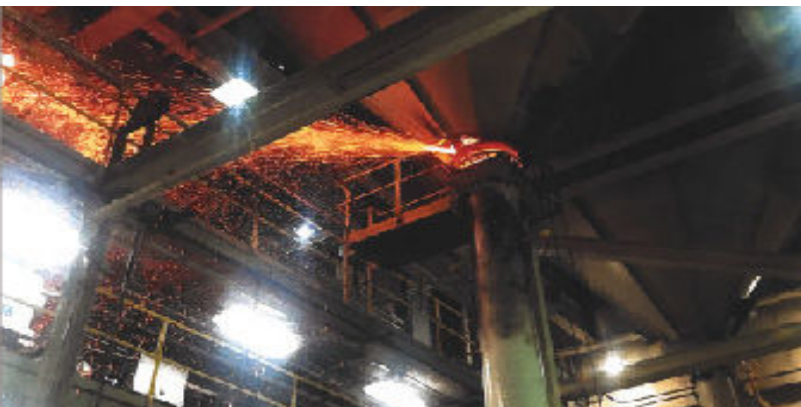
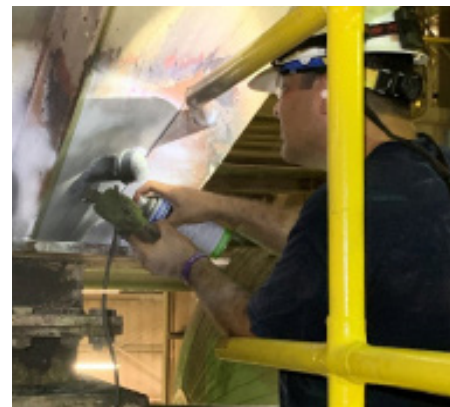
A CTLGroup Emergency Response Team comprised of a Principal Mechanical Engineer and Senior Metallurgist were dispatched to the power plant for performance of a site inspection and metallurgical review, in order to evaluate the post-incident soundness of the subject coal bunker. The Emergency Response Team performed an in situ inspection of the subject coal bunker upon arrival at the plant, then carefully cleaned the plates comprising the coal bunker using perchloroethylene and a wire brush to remove residual burned paint and prepare selected areas of the subject bunker for subsequent magnetic particle testing.

Both the in situ visual inspection and magnetic particle testing revealed no evidence of thermally induced cracks within the bunker plates. The Emergency Response Team also noted that thermal stresses from the fire and containment quench were not significant enough to cause significant distortion of the coal bunker plates, associated hardware, or ancillary transport equipment. Based on assessment of the visual evidence and metallurgical review of the raw materials comprising the coal bunker, hardware, and transport equipment, CTLGroup was able to opine as to the structural integrity of the subject coal bunker. Discussions with responsible utility power plant personnel resulted in performance of minor repairs and the resumed operation of the subject coal bunker, albeit at a reduced capacity and safety margin.
